January 2023

West Rutland

Sidewalk Scoping Study

West Rutland TAP TA 21(8)

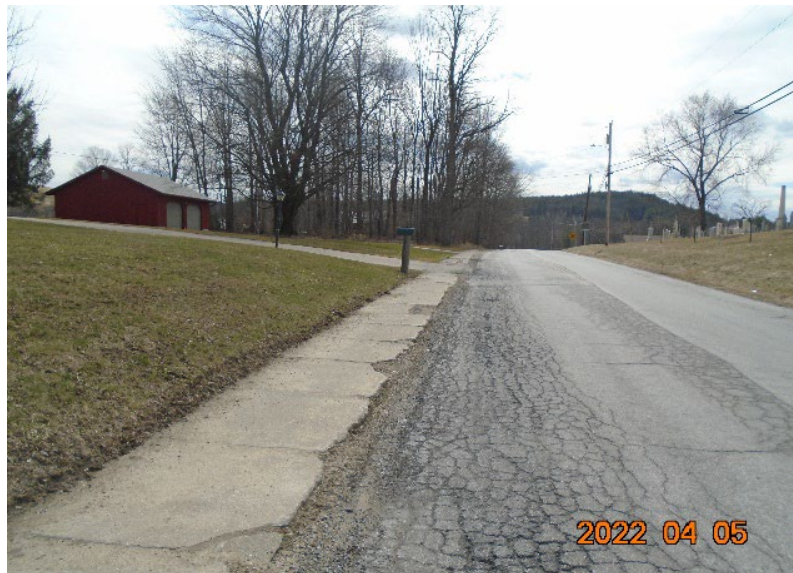
The existing sidewalk along the eastern side of Pleasant Street is in poor condition. While the roadway has been recently paved, no improvements were made to the pedestrian sidewalk as part of this pavement project. The sidewalk is constructed of concrete and is 4' wide. There are large portions of sidewalk that are deteriorating and cracking, creating trip hazards and ADA compliance issues. The curb material varies between concrete and granite. There are segments of road that do not have curb installed, and the height of the curb varies between 1" and 7". Curb cuts for existing residential driveways are not flush with the adjacent road or walkway. In addition, the sidewalk generally does not continue across the driveways, and the pavement is uneven in these areas. New curb ramps and a crosswalk have been installed at the intersection of Pleasant Street and Main Street; however, the existing sidewalk ends approximately 90' to the north, preventing an ADA connection to the Pleasant Street sidewalk. The buffer zone between curb and edge of sidewalk varies between 4' and 5' and is comprised of a mix of grass and gravel.

View South from Pleasant Street towards Business Route 4

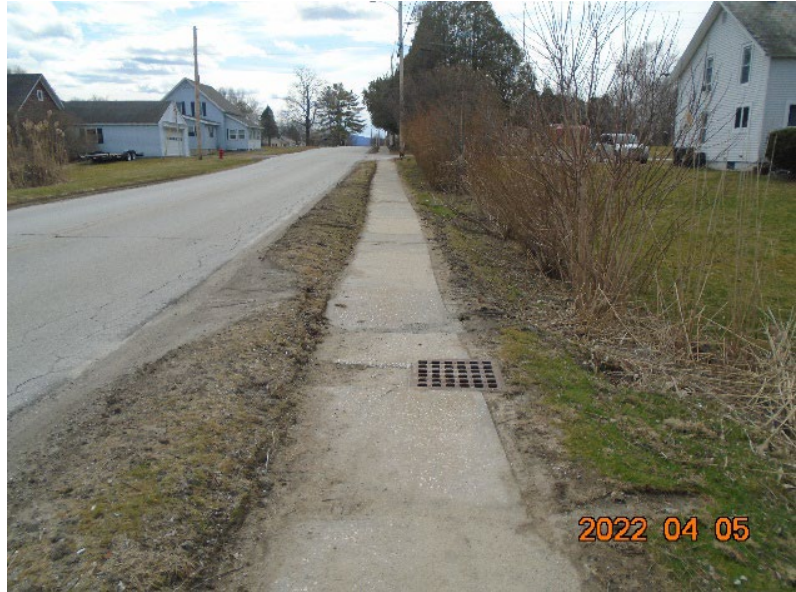
The existing sidewalk along the western side of Pleasant Street is in fair condition. The sidewalk is constructed of concrete and is 4' wide. The curb material is concrete and is generally 4" in height. The sidewalk has settled behind the curb, resulting in an uneven surface. The curb is flush at existing driveway curb cuts, and the sidewalk continues across the drives. There are two catch basins located within the sidewalk area, with evidence of ponding and washout from stormwater runoff. A drainage way crosses underneath the sidewalk and connects to the southernmost catch basin within the project area.

The sidewalk remains directly adjacent to the curb for the northern portion of the project area before the curb ends and the sidewalk cuts away from the road to create a 2' – 3' wide buffer zone. The buffer zone is comprised primarily of grass and slopes down away from the road. Utility poles are present along this area and are set approximately 2.5' off the western edge of the sidewalk. There is no curb ramp at the Baxter Street crossing, and the crosswalk markings are faded. No sidewalk exists to the north of the project area beyond Durgy Hill Road, and no sidewalks are present along Durgy Hill Road.

View South from Pleasant Street towards Baxter Street

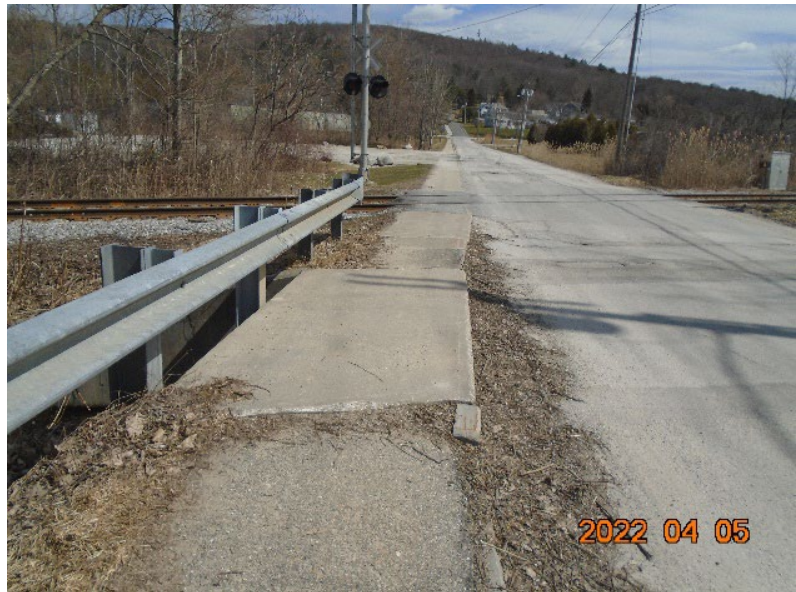
The existing sidewalk along the northern side of Thrall Avenue is in generally fair condition. The curb material is concrete and is generally 4" in height. The curb is in poor condition, and there are gaps in the curb from the stream crossing to just past the storage yard parking area. Portions of the sidewalk have settled behind the curb and adjacent to culvert, resulting in an uneven surface. The sidewalk is constructed of concrete and is 5' wide in front of the Park & Ride area before narrowing to 4' wide for the remainder of the corridor. The 5' segment appears to be more recently installed and is in good condition. The sidewalk is in very poor condition from the

View East on Thrall Avenue towards Railroad Crossing

stream crossing to the end of the storage yard parking area, with stark elevation changes between panels creating ADA compliance concerns. At the rail crossing, it was observed that the flashing warning lights did not appear to activate when a train went through. The sidewalk remains directly adjacent to the curb for the entirety of the project area with no buffer zone. A recently installed curb ramp at the intersection of Thrall and Sheldon Avenue is in good condition, however the transition from this curb ramp to the Thrall Avenue sidewalk is constructed of asphalt and does not appear to be ADA compliant. There is no crosswalk connecting the Thrall Avenue sidewalk to the newly installed sidewalk facilities on the other side of Sheldon Avenue.

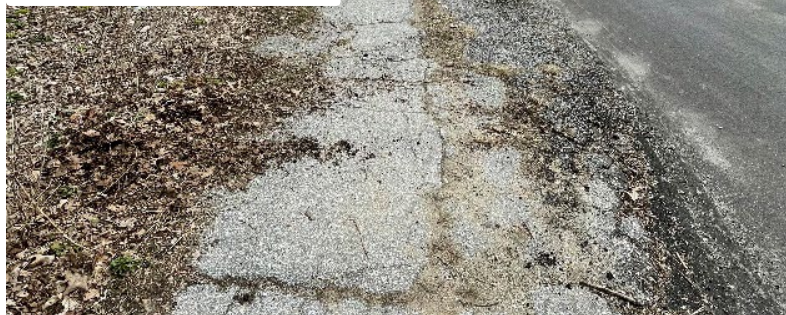
There is currently no formal sidewalk system along the northern side of Ross Street near the intersection of Main Street & Clarendon Avenue. The remnants of what appears to be an asphalt walk are in very poor condition with extensive cracking / heaving, and the transition to the concrete sidewalk to the west of the project site is not ADA compliant. There is no curb in this area, and a catch basin and utility pole are located between the former asphalt walk and edge of roadway. The sidewalk facilities along Main Street and connecting to Clarendon Avenue appeared to be in fair condition, however there is no formal connection to this system from Ross Street.

View East from Corner of Rigg's Parcel towards Main Street

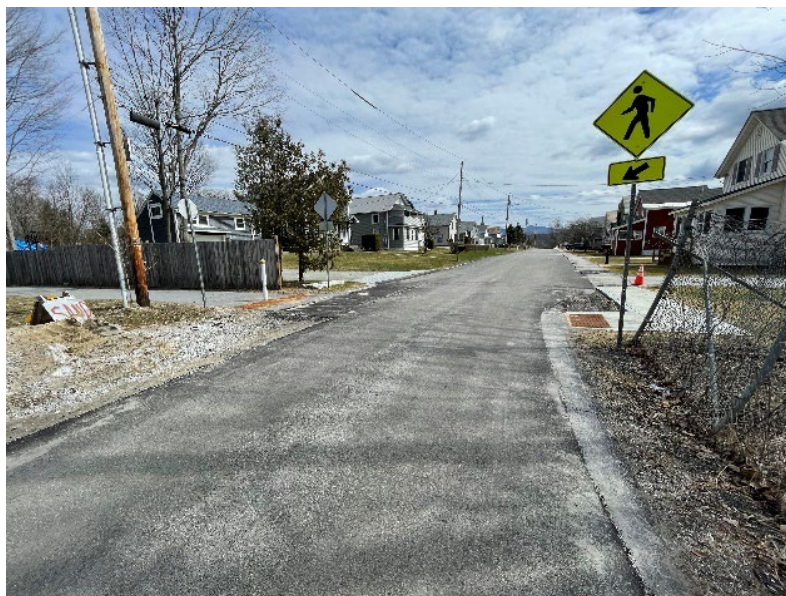
The existing asphalt sidewalk along the southern side of Ross Street is in generally fair condition. There is no curbing in this area, and the walk is directly adjacent to the edge of road, with multiple driveways intersecting with the walk. A newly installed curb ramp is located at the western most edge of the project area where Ross Street dead-ends, connecting to a newly installed multi-use path that runs north towards the school property. The asphalt walk was recently patched and there is minor cracking in several areas. The curb ramps located at the eastern end of the project area where Ross Street intersects with High Street, Chapel Street, and Franklin Street are in poor condition, with some evidence of deterioration and one of the detectable warning pads oriented in the incorrect direction. Crosswalk markings are faded in some places and missing in others where the roadway was recently repaved.

View East from End of Ross Street towards Shared Use Path Crossing

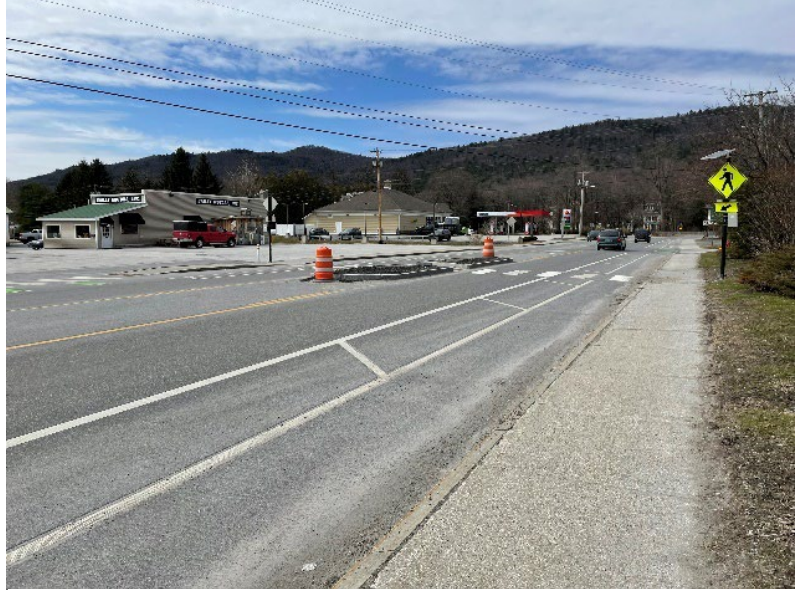
The existing condition of the 4' wide concrete sidewalk along the northern side of Main Street varies and is generally fair near the intersection of Main Street and Proctor Street, while getting progressively poorer towards the intersection of Main Street and Gilmore Street. Moderate cracking was evident in areas, and the sidewalk cross-slope is inconsistent, with some areas potentially not compliant with ADA guidelines. The curb material is granite and is generally 4" in height, with some sections missing at driveway crossings. The curb is in generally fair condition. The sidewalk remains directly adjacent to the curb for the entirety of the project area with no buffer zone. A buffered bike lane is installed along Main Street adjacent to the sidewalk area. Curb ramps were located at intersections, and crosswalk markings appeared to be in good condition. A solar-powered rectangular rapid flash beacon was located at the mid-block crossing location and appeared functional.

View West down Main Street towards Mid-Block Crossing

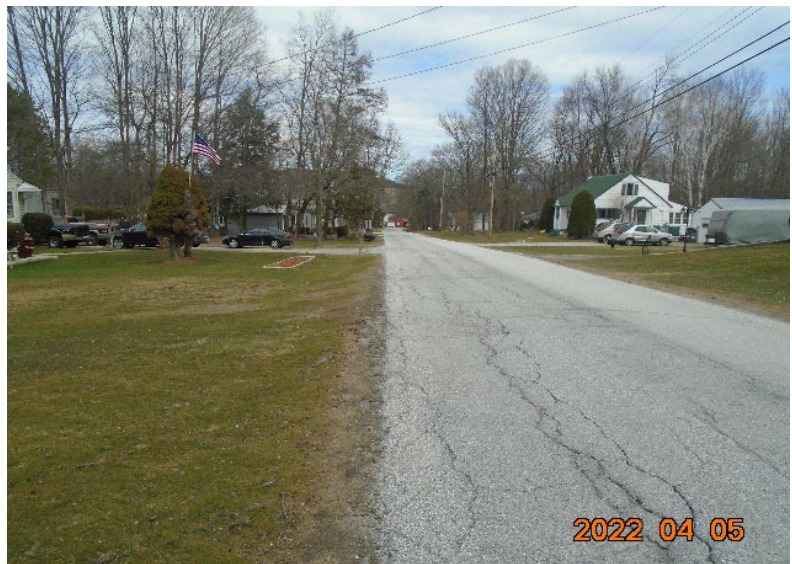
View North on Dewey Avenue towards Fox Run Lane

There is currently no sidewalk installed on either side of Dewey Avenue. Newly installed curb, curb ramps, and crosswalk markings are installed at the recently reconfigured intersection of Dewey Avenue and Clarendon Avenue. Bike lanes and signage are located along Clarendon Avenue. Dewey Avenue is approximately 24' wide with two 12' drive lanes and no marked shoulders. Utility poles are located along the project corridor, on both sides of the roadway. The poles are generally 6' off the edge of the road, however a few are located as close as 3' off the edge of road. Private property signs are located prominently

along the southern side of Dewey Avenue where the grade drops to a bench before forming a ravine near the intersection of Clarendon Avenue and Dewey Avenue. There are multiple driveways, mailboxes, and landscape areas located near the edge of pavement along the project area. There are no sidewalk facilities located south of the project area or along Clark Hill Road. Two catch basins are located on either side of Dewey Avenue where it intersects with Clark Hill Road that have settled significantly.

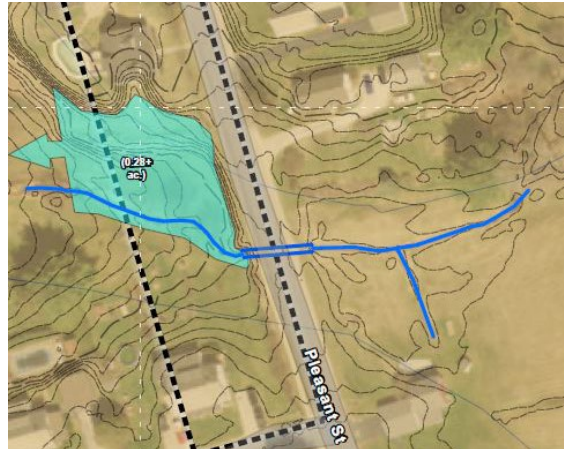
Area 2 does not contain any known floodways, river corridors, shorelines, or occurrences of RTE species. A wetland and an unnamed stream were found in the southern portion of the project area. The wetland extends to the west, is approximately 0.28 acres in size, is characterized as a shallow emergent marsh, and is presumed to be a Class II protected wetland. Mature trees in front of 1262 Pleasant Street were observed as being potentially significant and should be preserved. This residence is located on the opposite side of the street as the study area, and no impact is anticipated. As this area has been previously developed, the archaeological potential is generally low. No further archaeological review was recommended for this area due to the existing disturbance.

Stream Crossing Location on Pleasant Street

Construction of any potential alternative may possibly impact the wetland and require permitting depending upon the limit of work. Implementation of a retaining wall or similar system to minimize impacts beyond the edge of sidewalk may mitigate potential impacts to the wetland and waterbody.

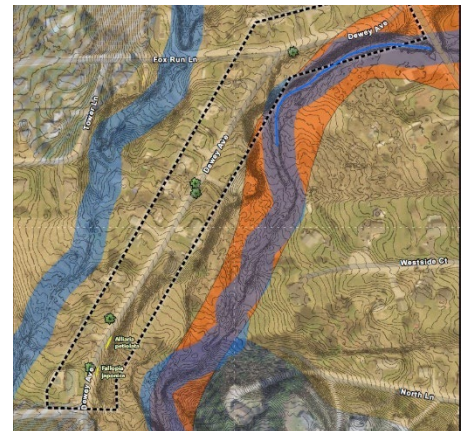
Area 7 currently does not have any sidewalks. This study area was found to contain no known wetlands, shorelines, or occurrences of RTE species, however there is an unnamed tributary to the Clarendon River in the eastern portion of the project area. A mapped FEMA flood hazard area and river corridor are associated with this tributary. The project area is mapped as primary agricultural soil. While no cultural or archaeological concerns were noted in this area, as the proposed sidewalk locations have not been previously developed, a Phase 1B Archaeological Study is recommended for this location.

Flood Hazard Area East of Dewey Avenue

A majority of the environmental and natural resources are located on the eastern & southern side of Dewey Avenue. Any potential alternative considered on this side of the roadway would have the same potential impacts to the tributary, flood hazard area, and agricultural soils. The northern portion of the roadway was found to contain fewer resources and may result in fewer potential impacts if construction were to occur.

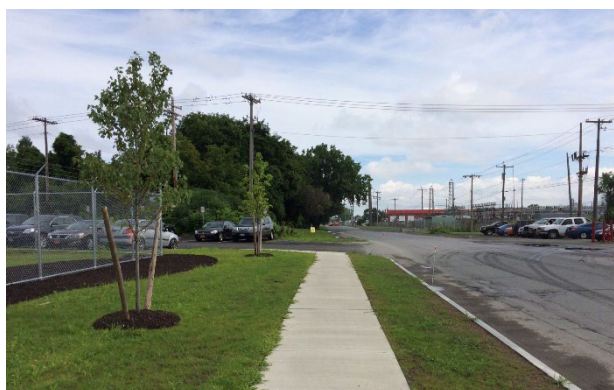
Sidewalk & Curb Example - Erie Blvd, Albany NY

Alternative 1 consists of a 4ft to 6ft wide concrete walkway, a vertical curb, and a buffer area between the top of curb and edge of sidewalk. The sidewalk should have a cross slope of no greater than 1.5% in one direction to aid in drainage. The direction of the cross slope can vary within project areas to best accommodate the surrounding topography. A 7" height granite curb is proposed to match existing site context. A buffer area of at least 2 feet in width is proposed, should have approximately the same longitudinal slope and cross slope as the adjacent sidewalk/roadway, and is not considered part of the travel way. The buffer can be constructed of "soft" materials, such as grass, gravel, or stone dust, or "hard" material such as asphalt or pavers. Soft materials are generally less expensive; however, grass can be difficult to maintain if the buffer zone is less than 3 feet, and loose material such as stone or gravel may wash or get kicked into the sidewalk area, impacting accessibility if not adequately maintained. While hard materials can be easier to maintain and maintain accessibility, they are also more expensive. This alternative is estimated to have an approximate cost of \$112.25 per linear foot.

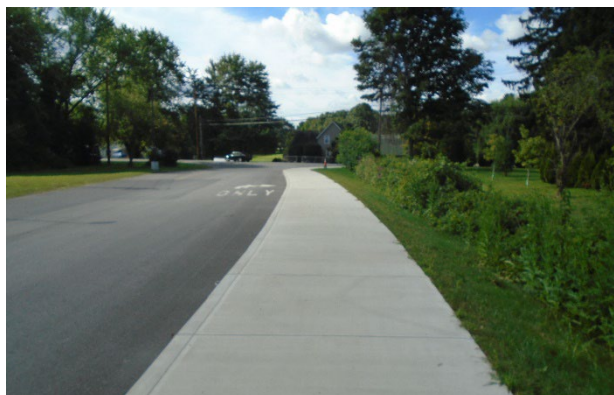
Integral Curb Example - Shaker HS Campus, Colonie, NY

Alternative 2 consists of a 4ft to 6ft wide concrete walkway and vertical curb. No buffer area is proposed in this alternative. The sidewalk should have a cross slope of no greater than 1.5% in one direction to aid in drainage. The direction of the cross slope can vary within project areas to best accommodate the surrounding topography. The curb is proposed to be 7" height granite to match existing site context. This alternative is estimated to have an approximate cost of \$111.75 per linear foot.

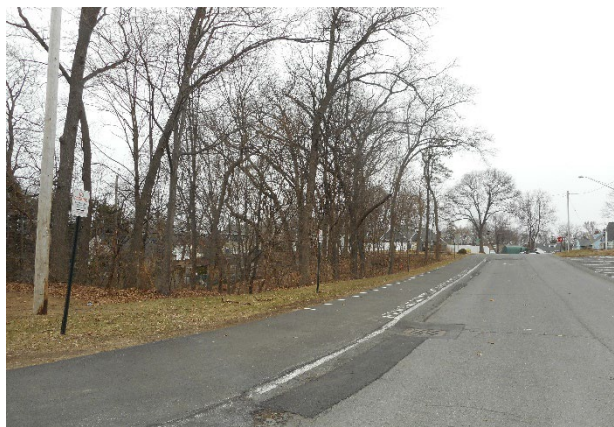
Alternative 3 consists of a 4ft to 6ft wide concrete walkway with a buffer area between the edge of roadway and edge of sidewalk, but no vertical curb. The sidewalk should have a cross slope of no greater than 1.5% in one direction to aid in drainage and the direction of the cross slope can vary within project areas to best accommodate the surrounding topography. A buffer area at least 2 feet in width is proposed and should have approximately the same slope and cross slope as the adjacent roadway / sidewalk and is not considered part of the travel way. The buffer can be constructed of "soft" materials,

At-Grade Sidewalk Example - Southgate ES, Colonie, NY

such as grass, gravel, or stone dust, or “hard” material such as asphalt or pavers. Soft materials are generally less expensive; however, grass can be difficult to maintain if the buffer zone is less than 3 feet, and loose material such as stone or gravel may wash or get kicked into the sidewalk area, impacting accessibility if not adequately maintained. While hard materials can be easier to maintain and maintain accessibility, they are also more expensive. This alternative is estimated to have an approximate cost of \$62.25 per linear foot.

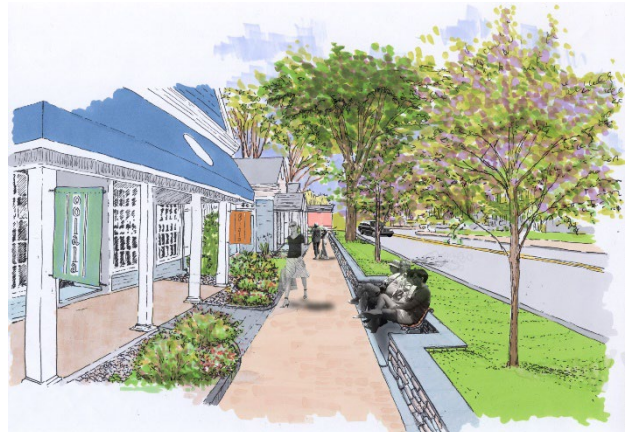
Alternative 4 consists of a 4ft to 6ft wide concrete walkway, with a 7” height granite vertical curb, a buffer area between the top of curb and edge of sidewalk, and a retaining wall on the far side of the sidewalk to minimize grading impacts to adjacent properties. The sidewalk should have a cross slope of no greater than 1.5% in one direction to aid in drainage. The direction of the cross slope may vary within project areas to best accommodate the surrounding topography. The curb is proposed to be granite to match existing site contexts and be the standard VTrans standard 7” height. A buffer area at least 2 feet in width is proposed. This buffer should have approximately the same slope and cross slope

Retaining Wall Example - Concept Sketch, Falmouth, MA

as the sidewalk and is not considered part of the travel way. The buffer can be constructed of “soft” materials, such as grass, gravel, or stone dust, or “hard” material such as asphalt or pavers. Soft materials are generally less expensive; however, grass can be difficult to maintain if the buffer zone is less than 3 feet, and loose material such as stone or gravel may wash or get kicked into the sidewalk area, impacting accessibility if not adequately maintained. While hard materials can be easier to maintain and maintain accessibility, they are also more expensive. The retaining wall should be limited in length and height to the minimum amount necessary to mitigate grading impacts and reduce costs. A protective guide railing may be required in select areas if the wall height is to exceed 42 inches. The wall may be constructed of unit segmental block, concrete or other materials which should be determined during design. This alternative is estimated to have an approximate cost of \$213.25 per linear foot.

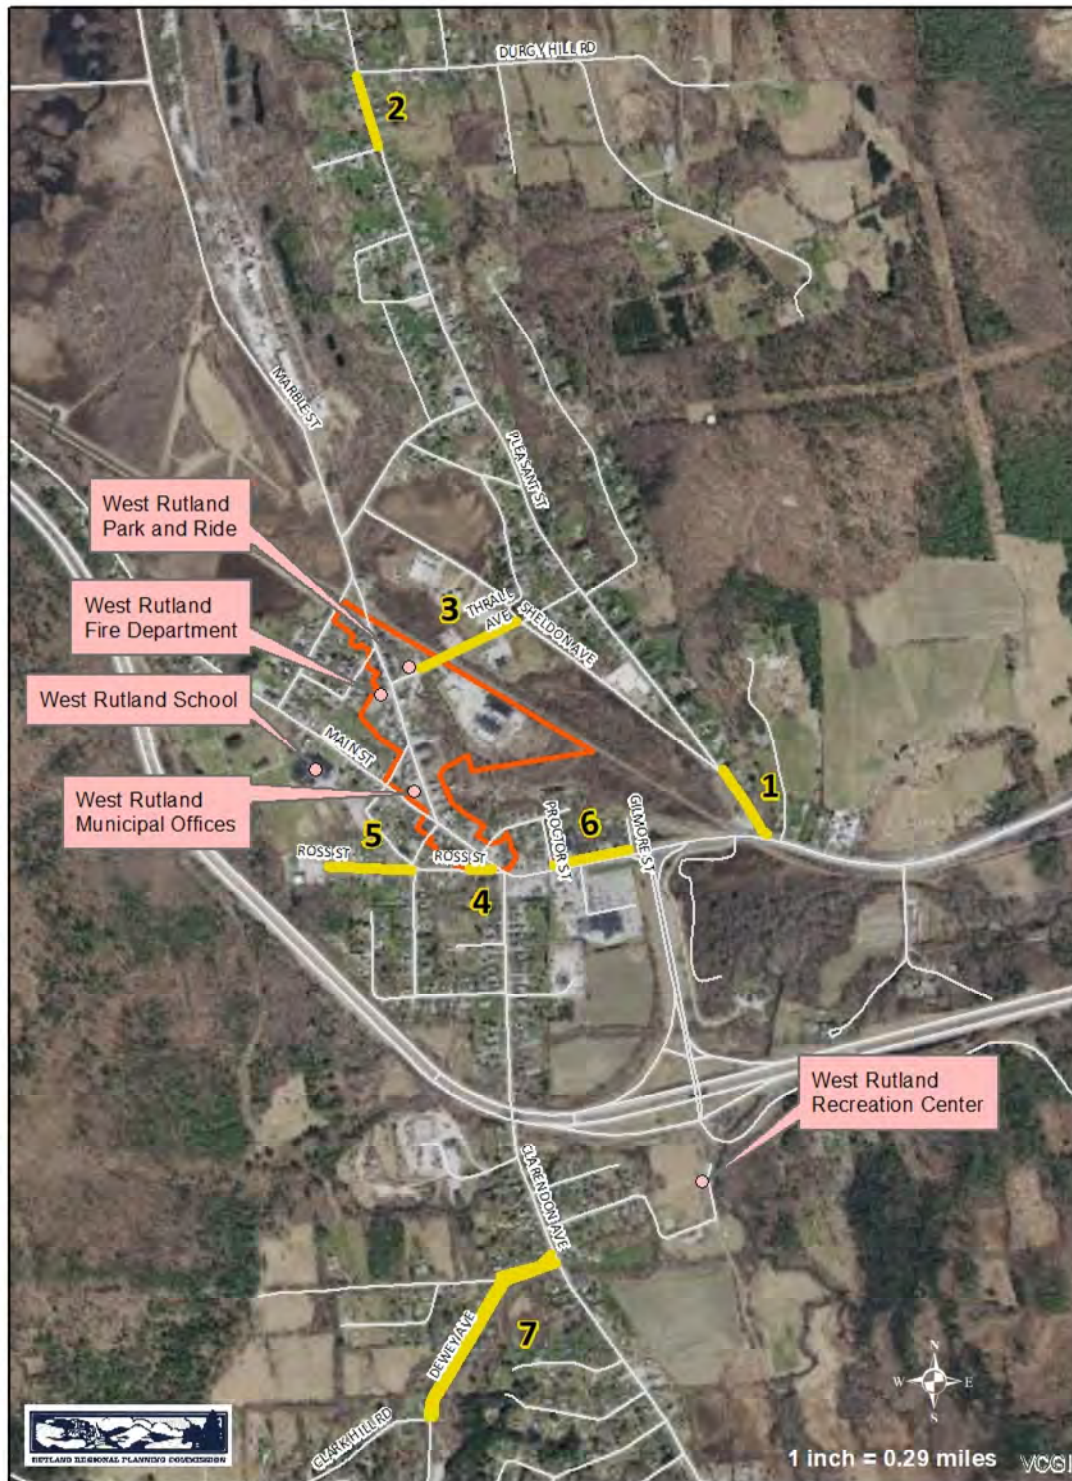
Location	Feet
1) Pleasant Street (east side) - Business Route 4 to Sheldon	635
2) Pleasant Street (west side) - Baxter to Durgy	588
3) Thrall (north side) - park & ride to Sheldon	850
4) Ross Street (north side) - Main to fence (end of Rigg's parcel)	179
5) Ross Street (south side) - Franklin to end	670
6) Main Street (north side) - Proctor to Gilmore	485
7) Dewey (both sides) - Clarendon to Clark Hill	1,728
Total	5,135

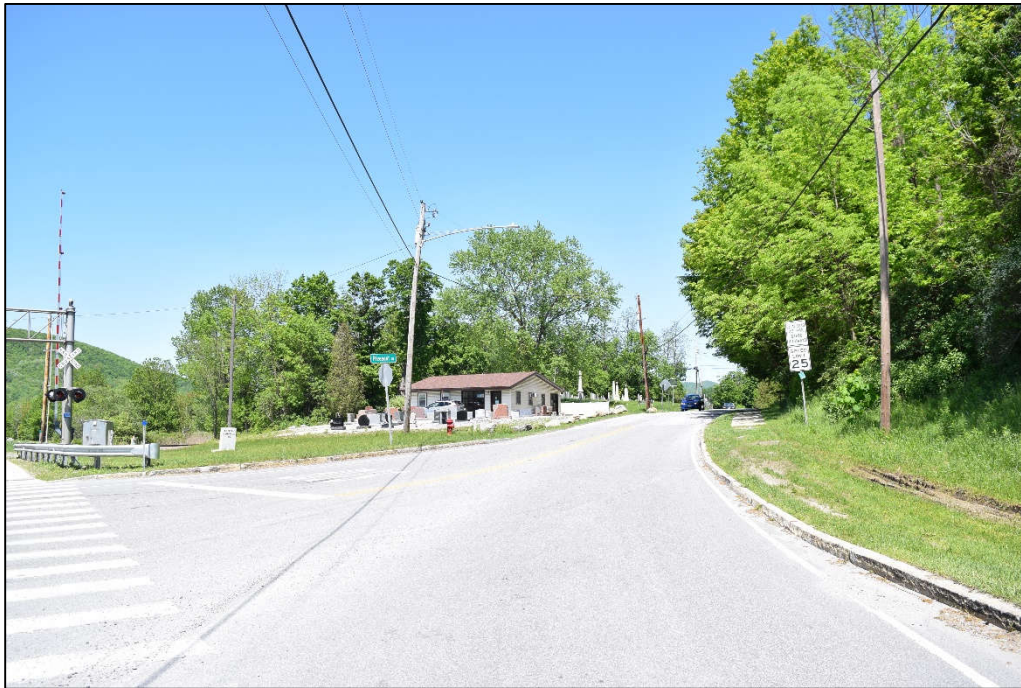
The existing sidewalk along the east side of Pleasant Street extends from Sheldon Avenue to just short of Business Route 4 (Photos 1 and 2). It passes in front of one recent house with recent and earlier houses located at the north end of the segment. The front lawn of the houses slopes down to the sidewalk. A storm drain drop inlet is noted under the sidewalk near the north end of the alignment. Across the street is the historic Pleasant Street Cemetery.

Photo 1. South end of Segment 1 at the intersection of Pleasant Street and Route 4. Note existing sidewalk that ends short of Business Route 4 on the right. View to the north/northwest.

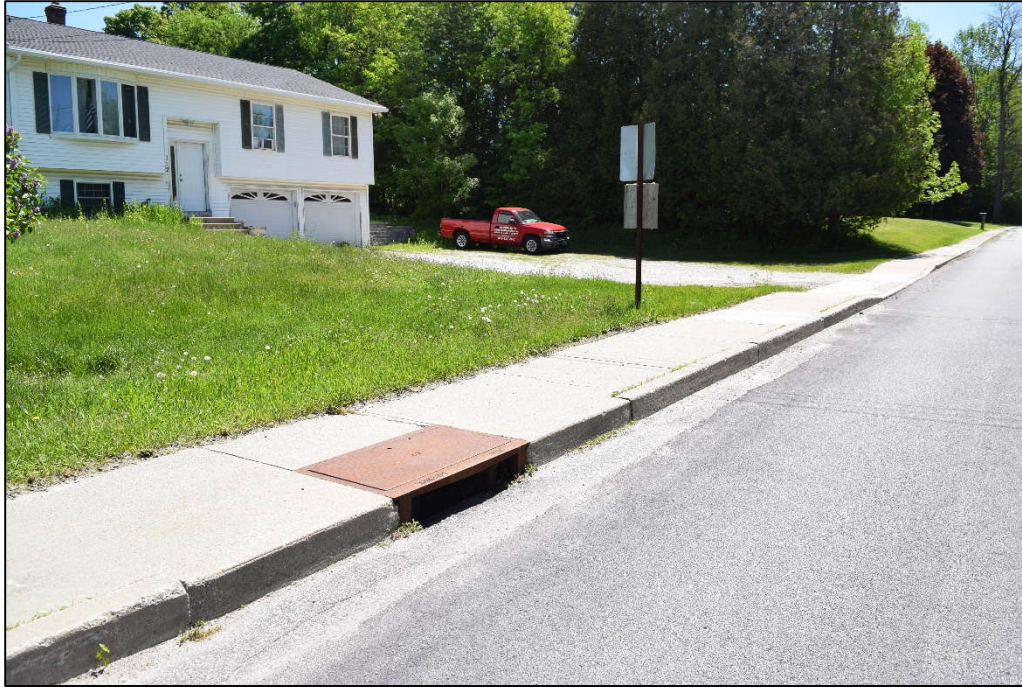
Photo 2. Detail of existing sidewalk on the north end of Segment 1. Note lawns sloping down to the road. View to the southeast.

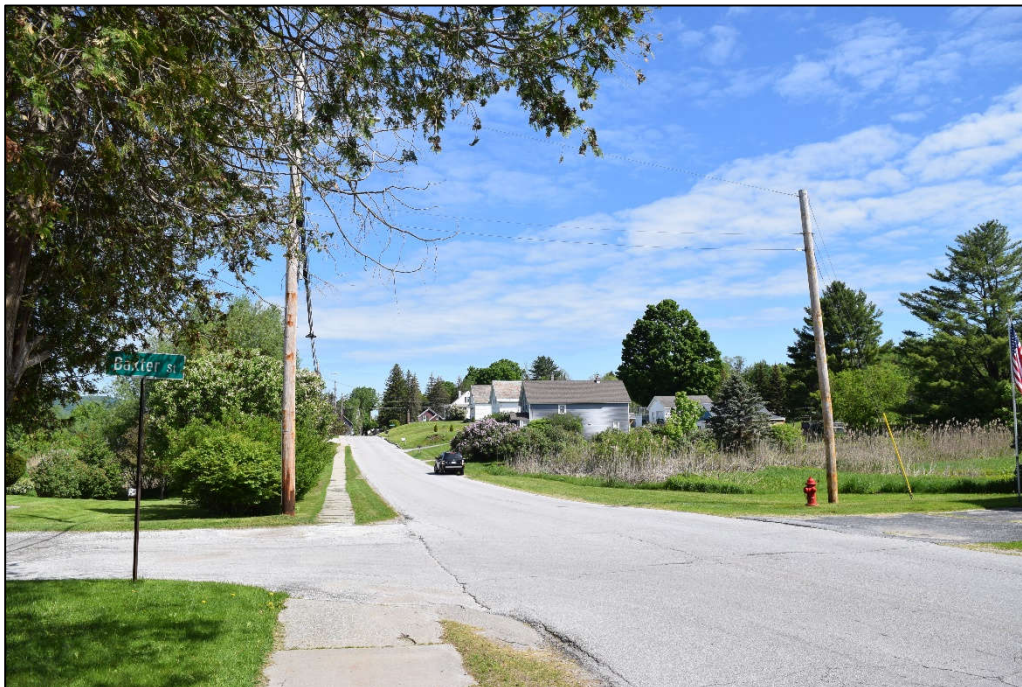
Photo 3. Segment 2, from Baxter Street to the north. Note existing sidewalk along the west side of Pleasant Street. View to the north.

Segment 2 is located on the west side of Pleasant Street between Baxter Street and Durgy Hill Road (Photos 3 and 4). As with Segment 1, Segment 2 is also on a sloped landscape with the properties on the eastern side of the road sloping down to the roadside and those on the west side constructed to some extent on fill sloping down away from the road to the west.

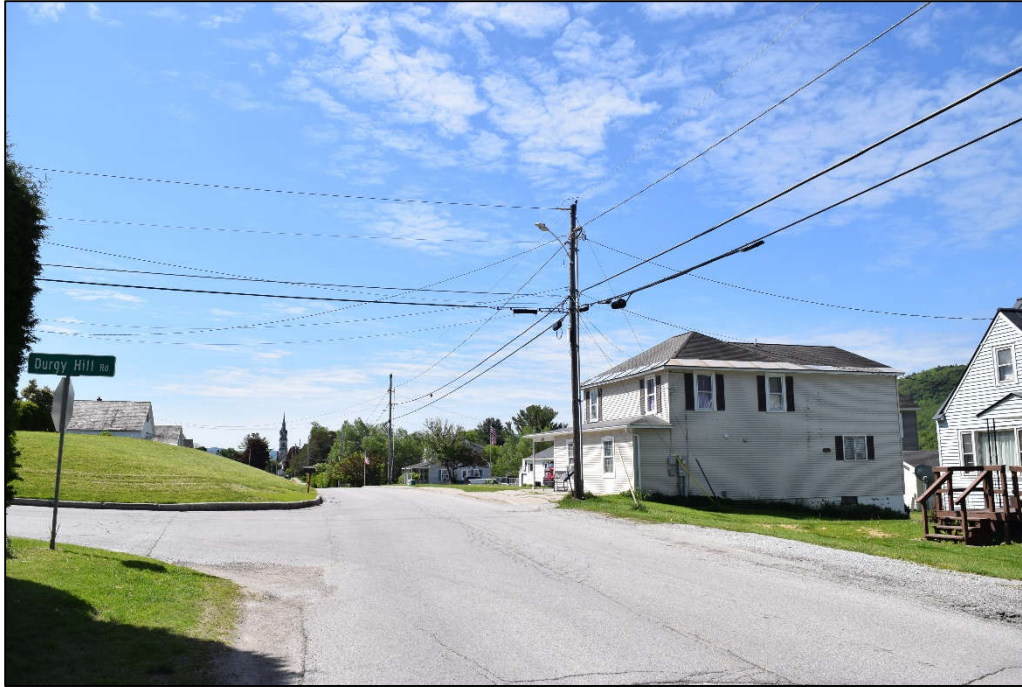
Photo 4. Segment 2, from Durgy Hill Road to the south. Note slope down from east to west (l-r) and existing sidewalk along the west side of Pleasant Street. View to the south.

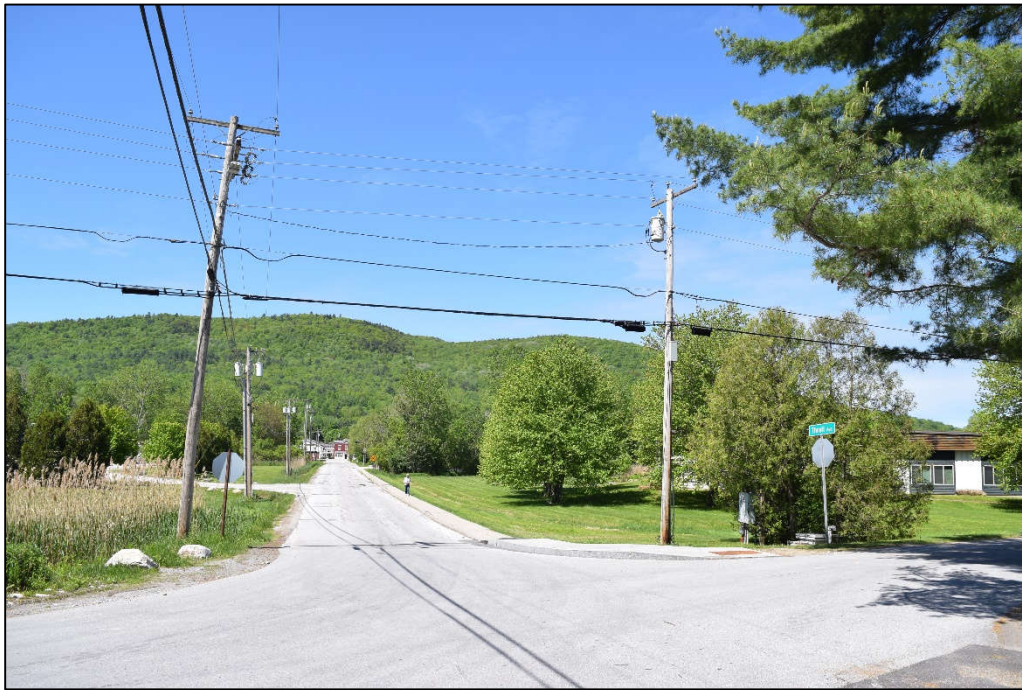
Photo 5. Segment 3, Thrall Avenue from Sheldon Avenue to the southwest. Note existing sidewalk along the north side of Thrall Avenue. View to the southwest.

The Thrall Avenue segment extends along the north side of the street on an existing sidewalk from the intersection with Sheldon Street on the east to the park and ride lot on the west (Photos 5 to 7). The adjacent areas to the APE are lawns with ditches to facilitate drainage.

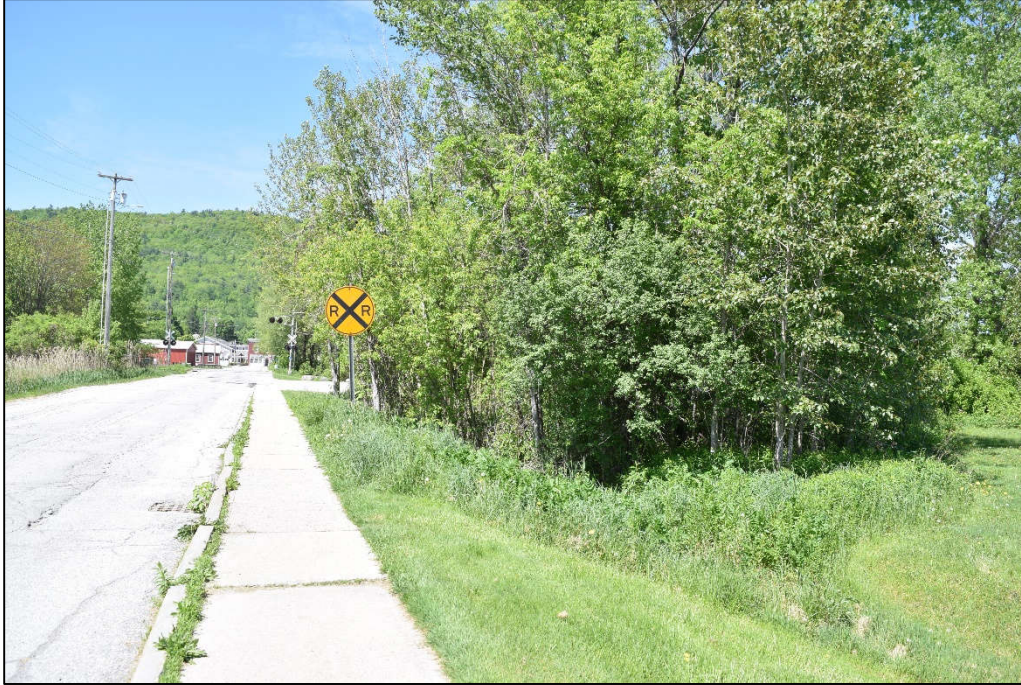
Photo 6. Segment 3, Thrall Avenue to the southwest. Note existing sidewalk along the north side of Thrall Avenue. View to the southwest.

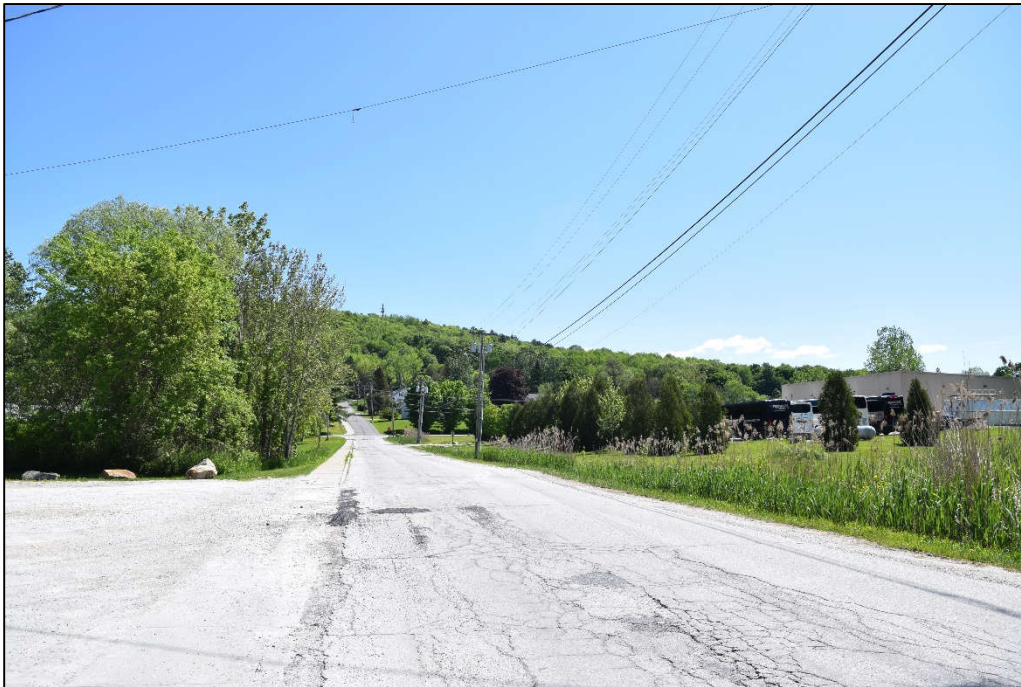
Photo 7. Segment 3, from park and ride to the northeast. Note existing sidewalk along the north side of Thrall Avenue. View to the northeast.

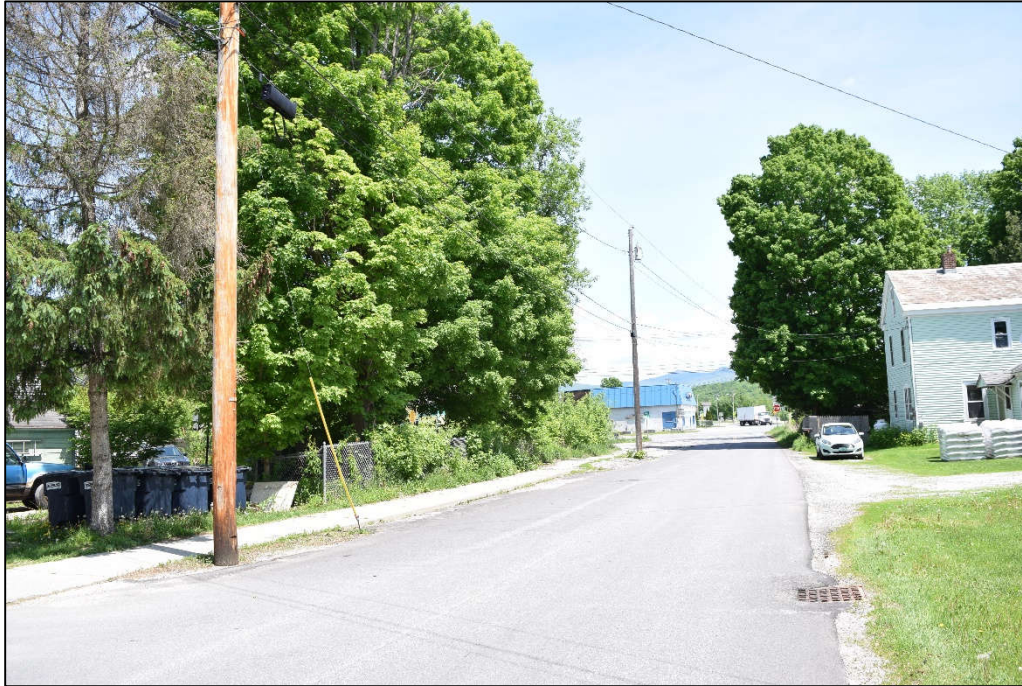
Segment 4 extends from Main Street approximately 179 feet (55 m) along the north side of the street. An existing sidewalk is present along the alignment (Photo 8). The sidewalk has significant deterioration and runs adjacent to an empty lot that once had a structure within a few feet of the APE (Photo 9).

Photo 8. Segment 4, east end of Ross Street. Note existing sidewalk along the north side of Ross Street with Main Street in the background. View to the east.

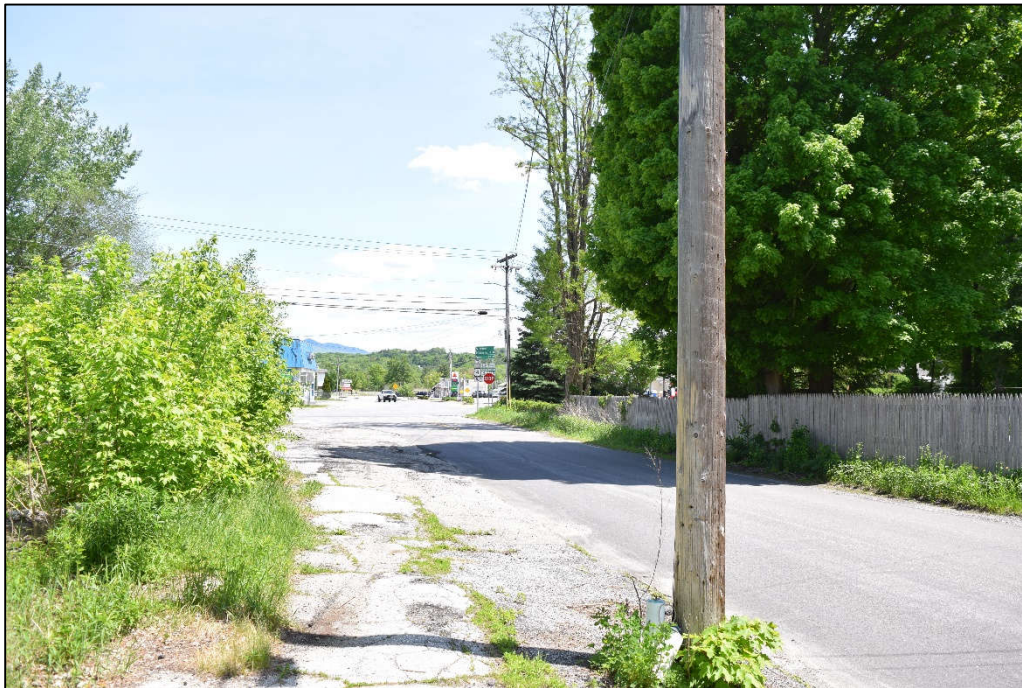
Photo 9. Segment 4, toward Main Street. Note deteriorated existing sidewalk along the north side of Ross Street. View to the east.

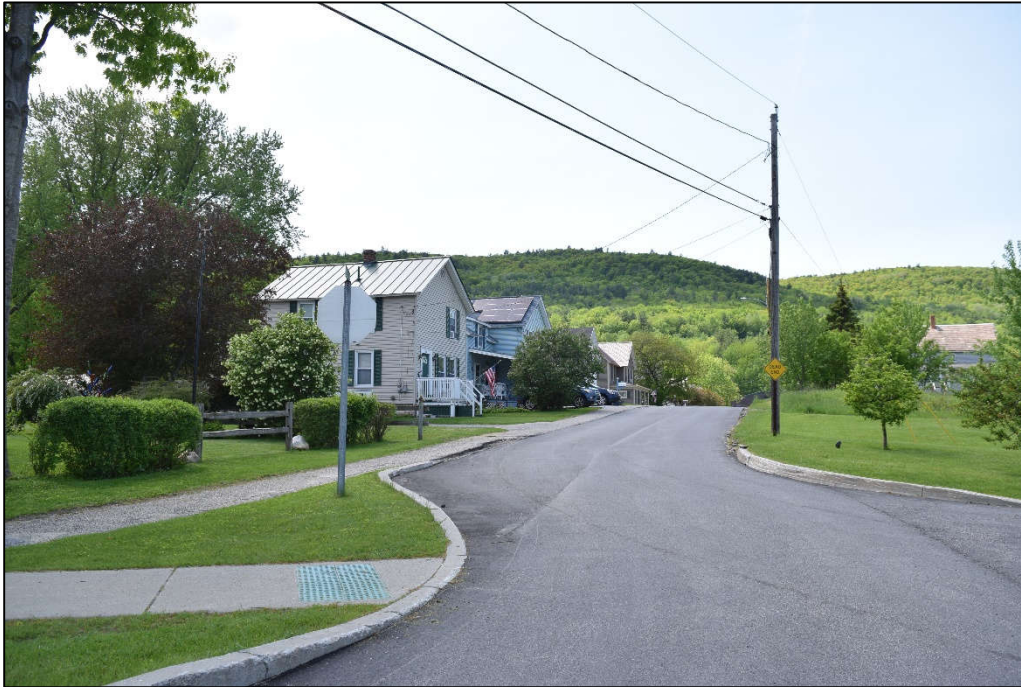
Photo 10. Segment 5, from the Franklin Street intersection to the west. Note existing sidewalk along the south side of Ross Street. View to the west.

Segment 5 extends along an existing asphalt sidewalk on the south side of Ross Street (Photos 10 and 11). It passes in front of several residential properties and ends at the west end of Ross Street.

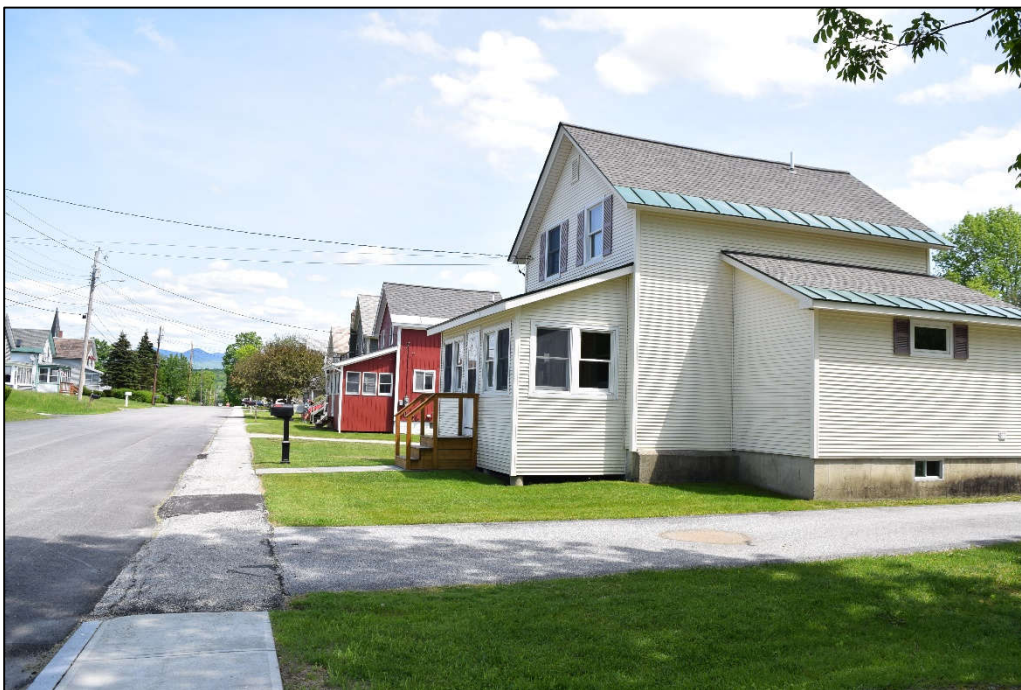
Photo 11. Segment 5, from the west end of Ross Street to the east. Note deteriorating existing sidewalk along the south side of Ross Street. View to the east.

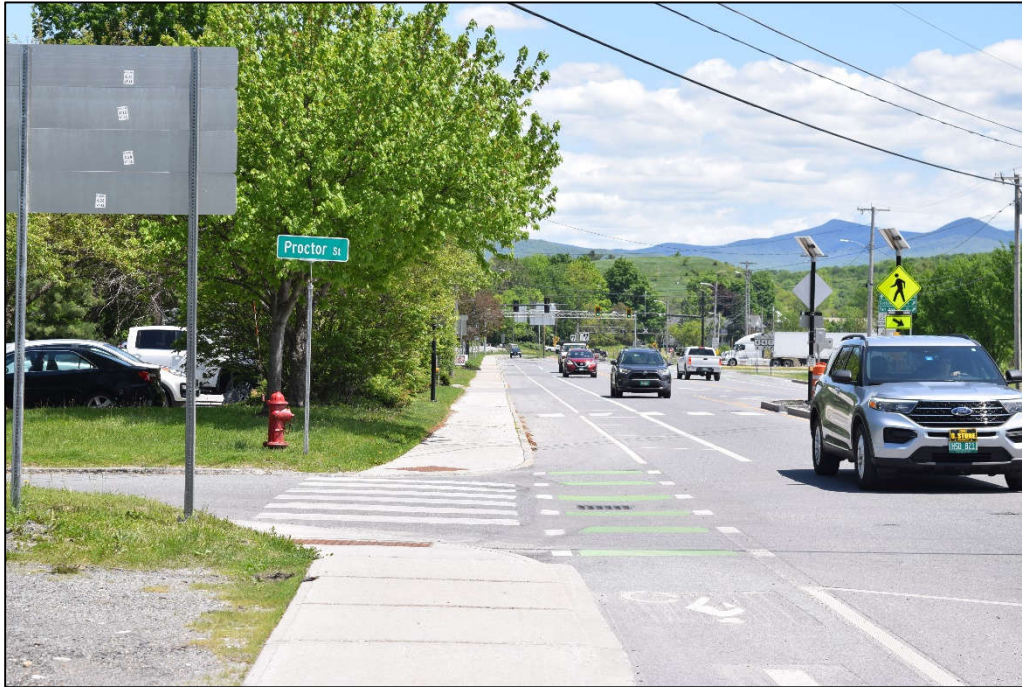
Photo 12. Segment 6, from Proctor Street to the east. Note existing sidewalk along the north side of Main Street. View to the east.

Segment 6 extends along the north side of Main Street between Proctor and Gilmore Streets (Photos 12 and 13). The alignment passes in front of several residential and commercial properties.

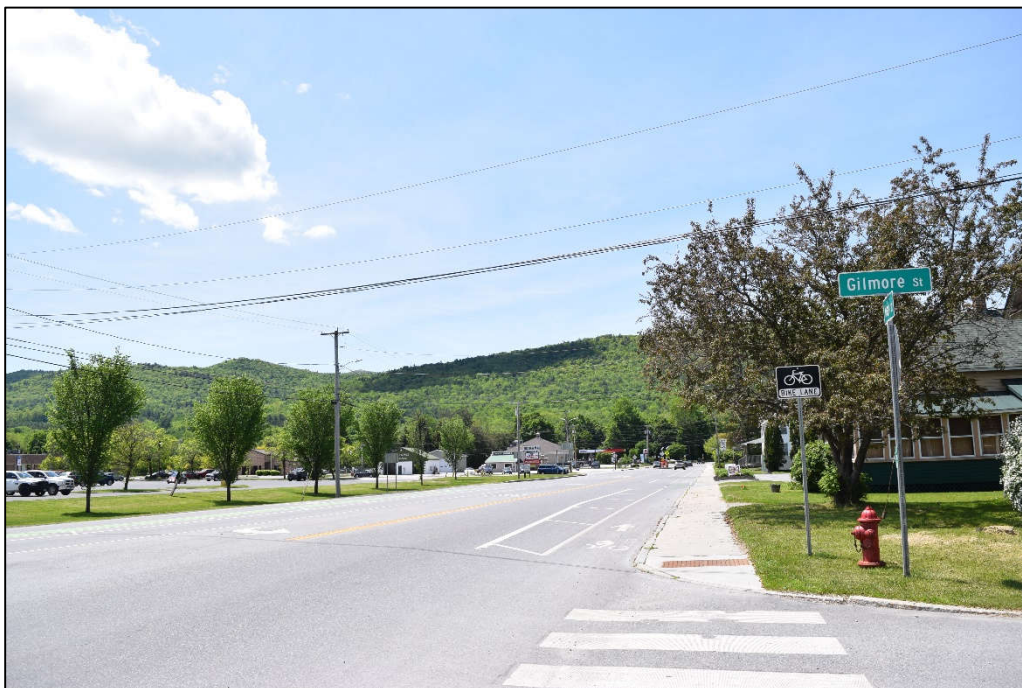
Photo 13. Segment 6, from Gilmore Street to the west. Note existing sidewalk along the north side of Main Street. View to the west.

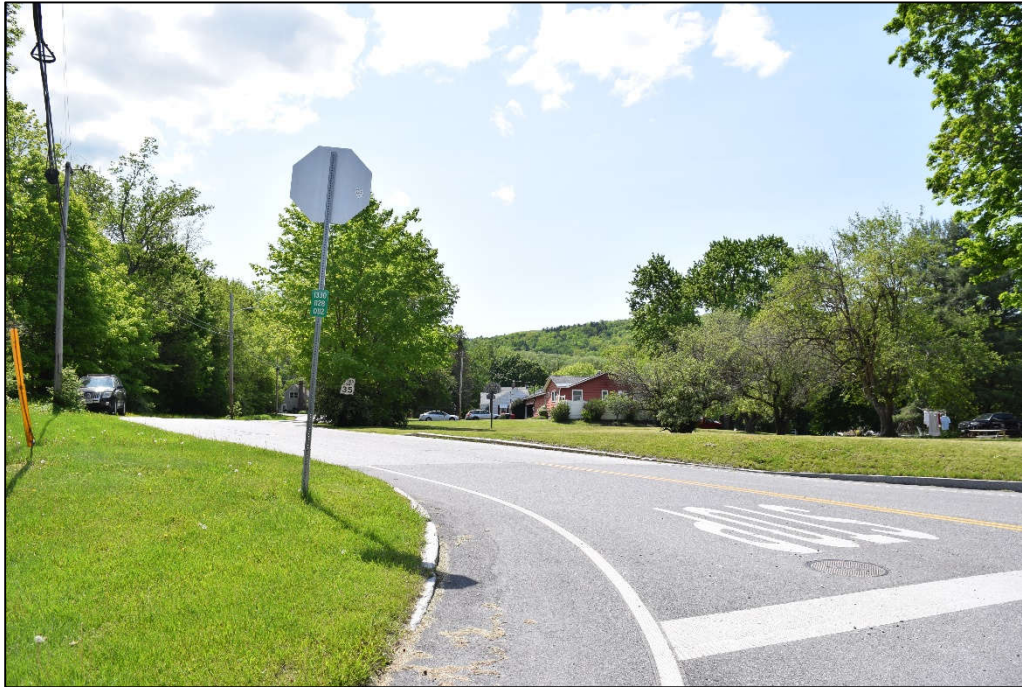
Photo 14. Segment 7, from Clarendon Avenue to the southwest. Note lack of sidewalk on both sides of Dewey Avenue. View to the southwest.

Dewey Avenue is a residential street extending from Clarendon Avenue to the southwest (Photos 14 to 16). No sidewalks are present along the alignment.

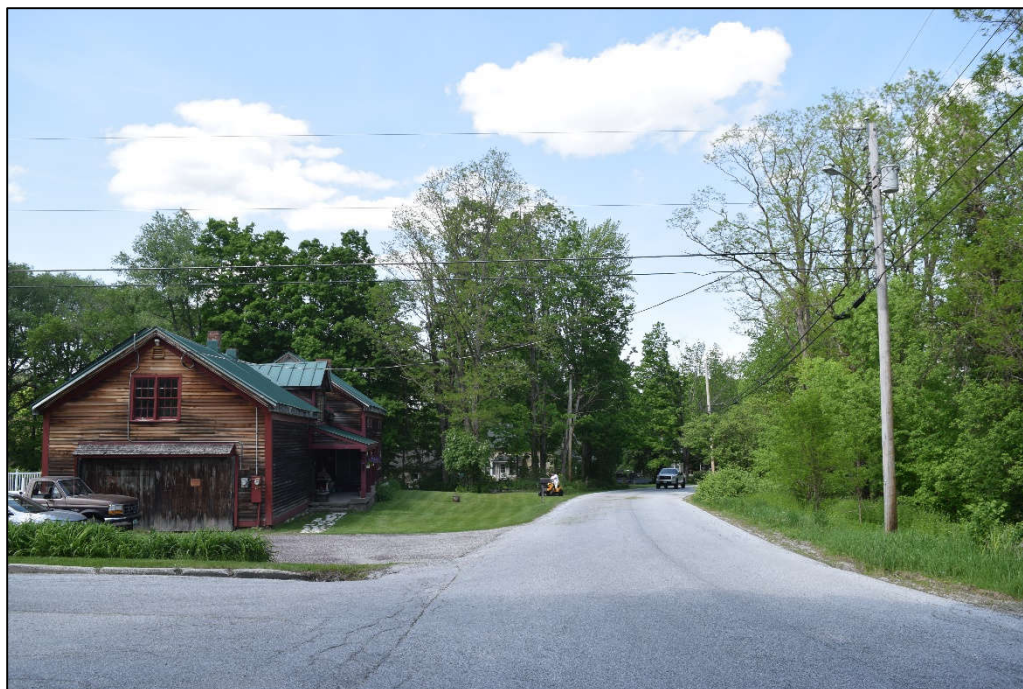
Photo 16. Segment 7, from the intersection with Clark Hill Road to the north. Note Clark Hill Road on the bottom left with Dewey Avenue extending to the background. View to the north.
