January 2023

West Rutland

Sidewalk Scoping Study

West Rutland TAP TA 21(8)

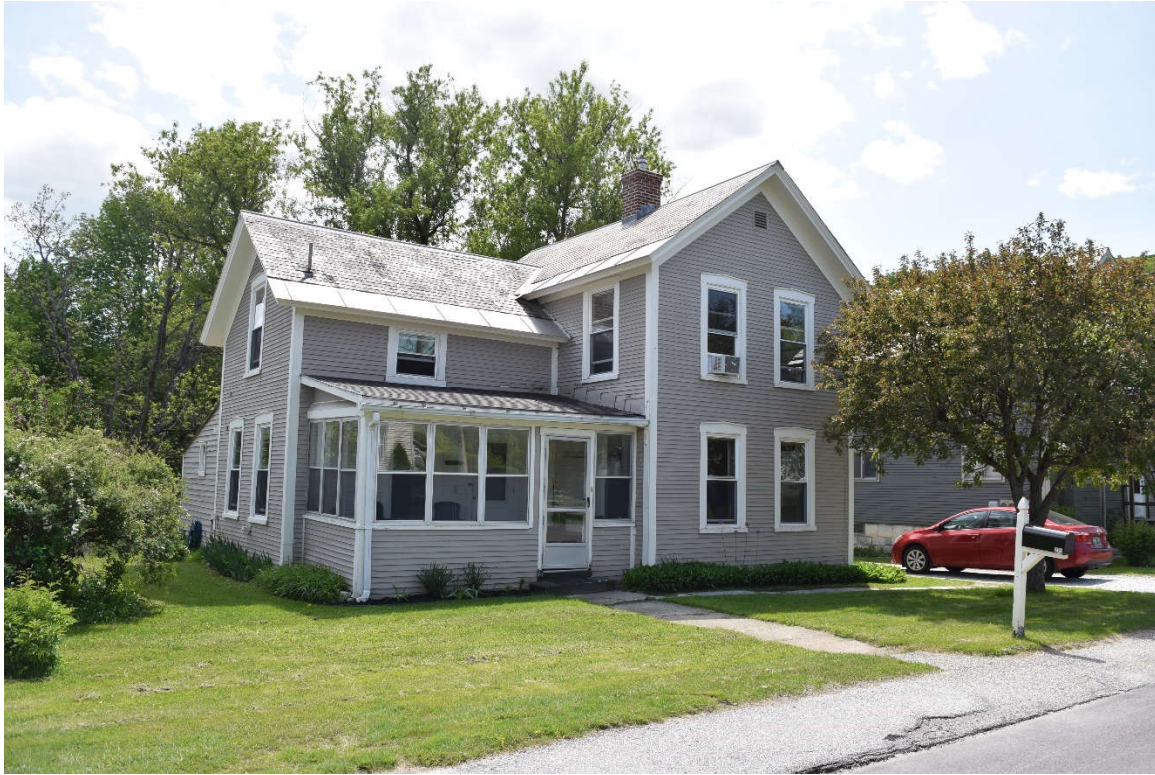
Photo 13. View of 225 Ross Street, facing southwest.

Several private sidewalks of local marble extend to the street. Public sidewalks and curbing are located adjacent to the street except along the north side of Ross Street, particularly at its west end. The sidewalks and curbs are of poured concrete or asphalt (Photos 8 and 13). Marble sidewalks in the public way may be located in front of 226 Ross Street, and possibly in other locations where they are either buried or covered with a layer of asphalt (Photo 14). Few mature plantings are located in close proximity to the street or sidewalk, and no historic fencing materials are associated with any of the properties in this area.

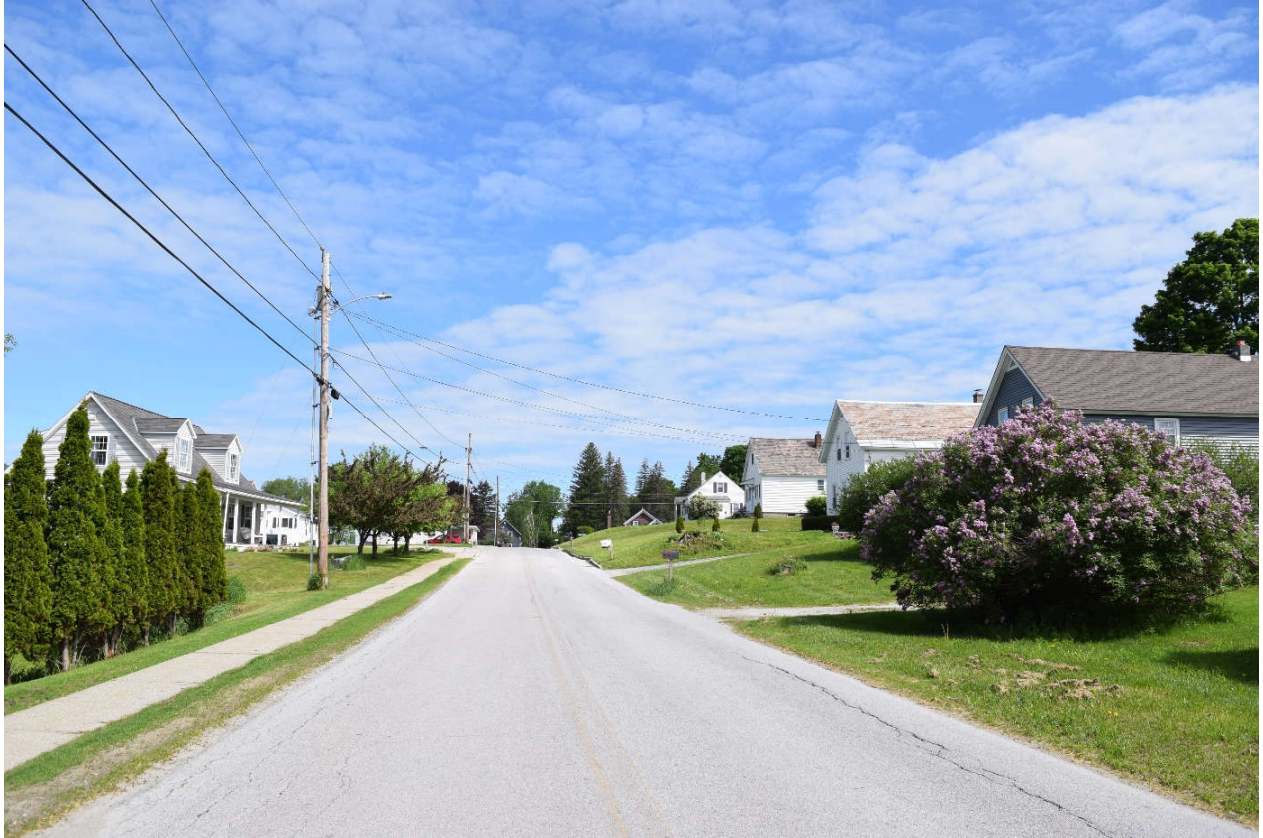
Photo 24. View of Pleasant Street, facing north-northwest.

Several houses have private walks of local marble in this group. Public sidewalks are typically of poured concrete, are separated from the street with a grassy border, and lack curbing (Photo 24). The sidewalk is located on the west side of the street, and at the north end of Segment 2 it is located immediately adjacent to the street and has a concrete curb. Concrete curbing borders much of the east side of the street.

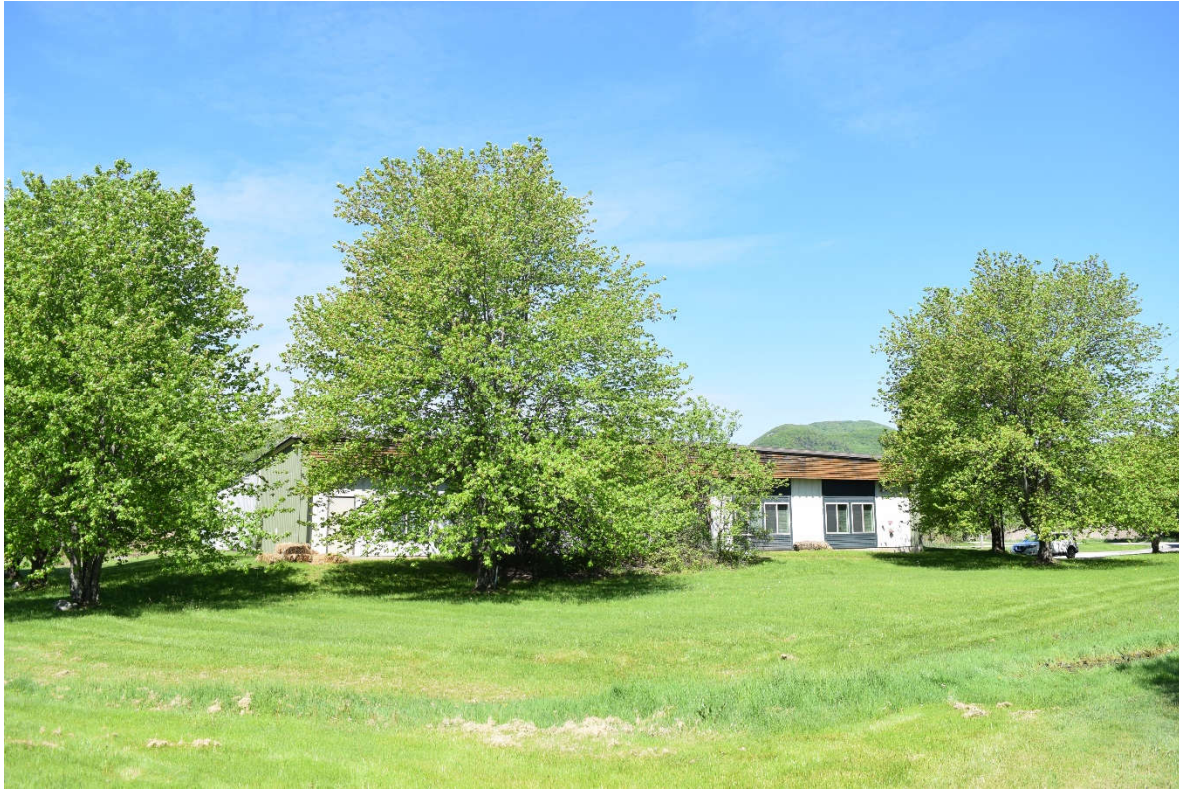
Photo 46. View of West Rutland Pump Station building on Thrall Avenue, facing north.

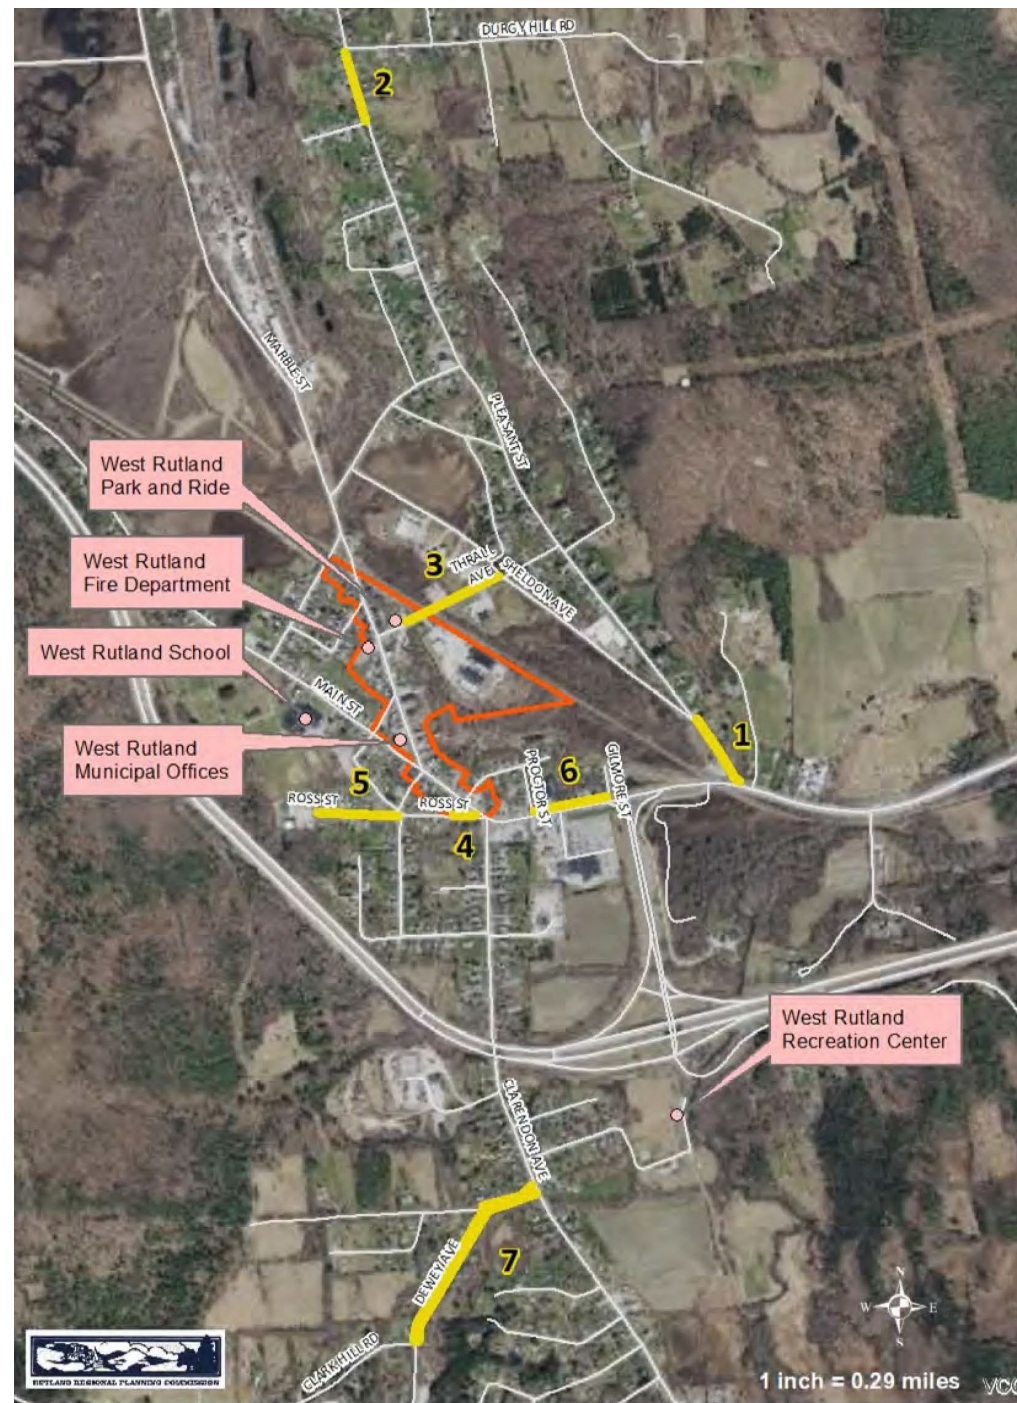
Various Conditions:

- Concrete sidewalks with curbs
- Sidewalk settlements
- Poor condition, extensive cracking & heaving
- ADA Compliance
- Curb Ramps + Crosswalks

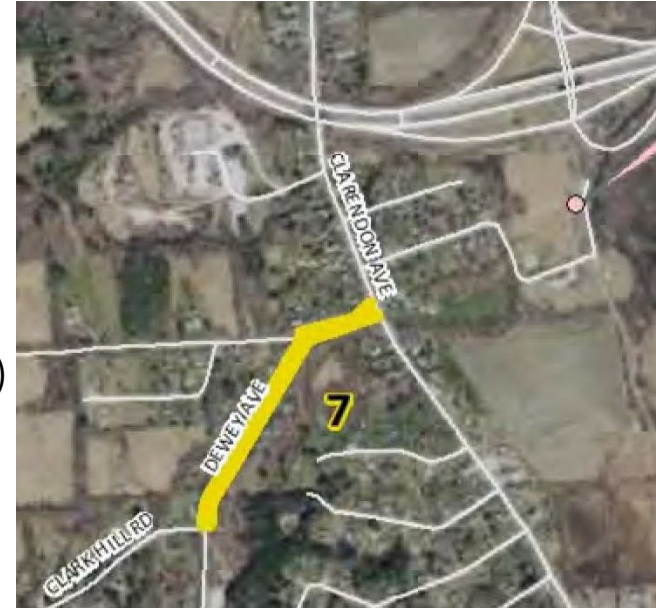
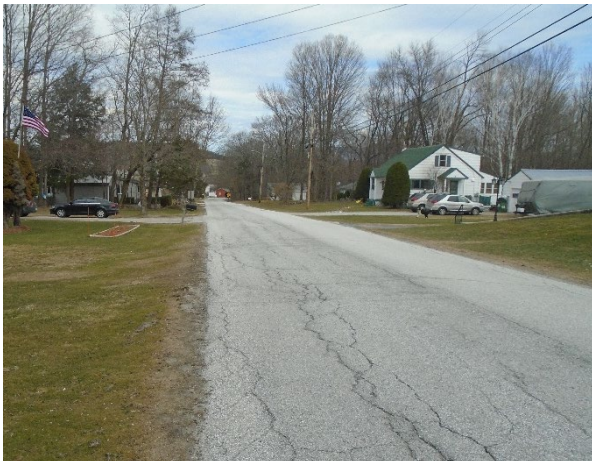
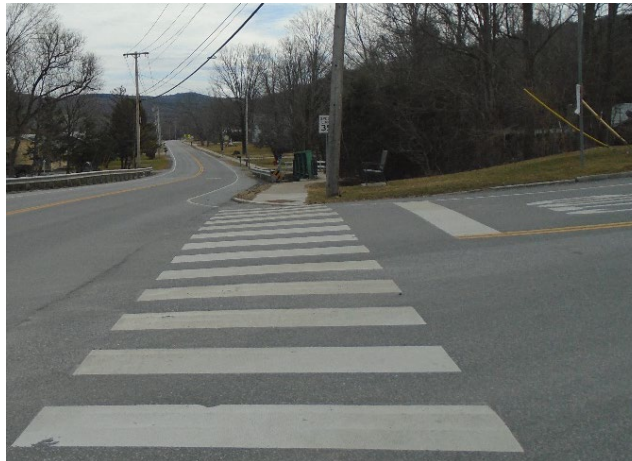
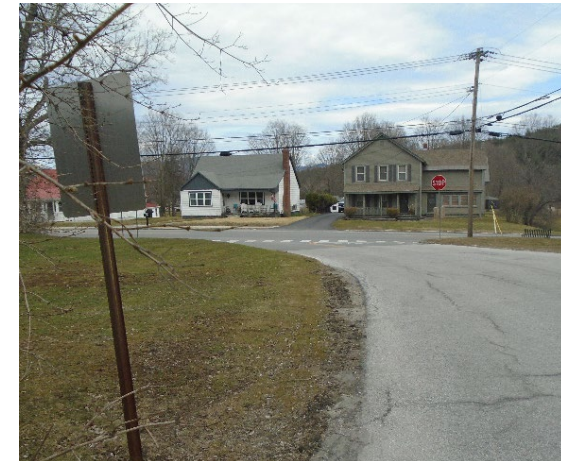
Area 7 – evaluate both sides of dewey avenue
(clarendon avenue – clark hill road)

- Residential Area with no sidewalk or curb
- Corridor is approximately 1/3rd mile
- New curb ramps/crosswalks at Clarendon Ave
- Multiple driveways
- Utility poles on both sides of road (crosses frequently)
- Bike lanes & signage along Clarendon Avenue
- Topography/invasive species on eastern side of corridor
- Speed limit recently reduced to 25 mph

general issues with the sidewalks (heaving, cracking, etc.). Provided a more in depth analysis of Area 7 (both sides of Dewey Avenue from Clarendon Ave to Clark Hill Road), as this is the only area without existing sidewalks.

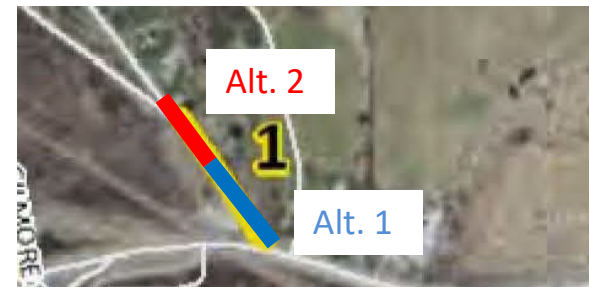
area 1 – pleasant street

Preferred Alternative(s):

Alt. 1 – Sidewalk w/ Curb

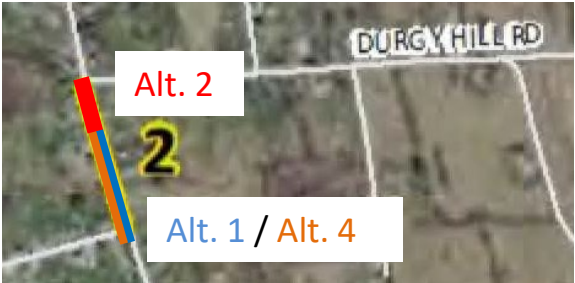
area 2 – pleasant street

Preferred Alternative(s):

Alt. 1 – Sidewalk w/ Curb

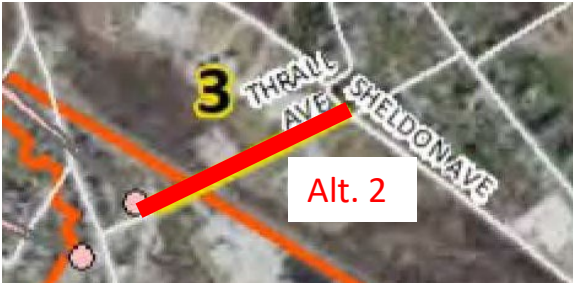
area 3 – thrall avenue

Preferred Alternative(s):

Alt. 1 – Sidewalk w/ Curb

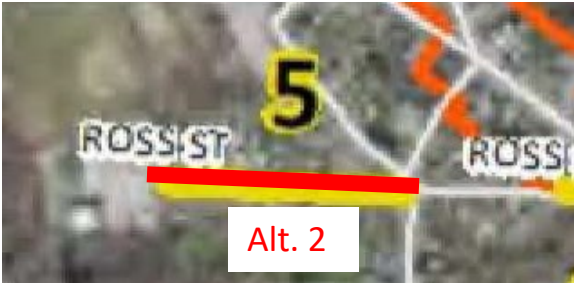
area 5 – ross street

Preferred Alternative(s):

Alt. 1 – Sidewalk w/ Curb

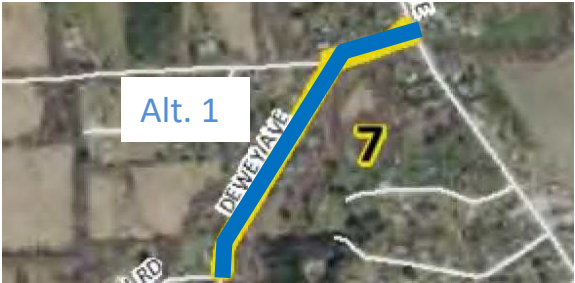
area 7 – dewey avenue

Preferred Alternative(s): North Side

Alt. 1 – Sidewalk w/ Curb
